# Damage Evaluation and Seismic Assessment of a Typical Historical Unreinforced Masonry Building in the Zagreb 2020 Earthquake: A Case Study—Part I

Source / Izvornik: **Buildings, 2024, 14**

**Abstract:** The city of Zagreb, the national capital and economic hub of Croatia, is situated in a seismically active region and hosts a significant array of historical buildings, from the medieval to Austro-Hungarian periods. These buildings possess varying but generally high degrees of vulnerability to seismic loading. This was highlighted in the Zagreb earthquake of 22 March 2020, emphasizing the need for seismic retrofitting in order to preserve this architectural heritage. In this paper, the seismic capacity of one such unreinforced masonry building is considered through a number of analysis methods, including response spectrum, pushover, and out-of-plane wall failure analyses. Given the advantages and disadvantages of the individual methods, their applicability and value in a seismic analysis is considered. Ambient vibration measurements before and after the Zagreb 2020 earthquake, used for model calibration, are also presented. Conclusions are drawn from each individual analysis and

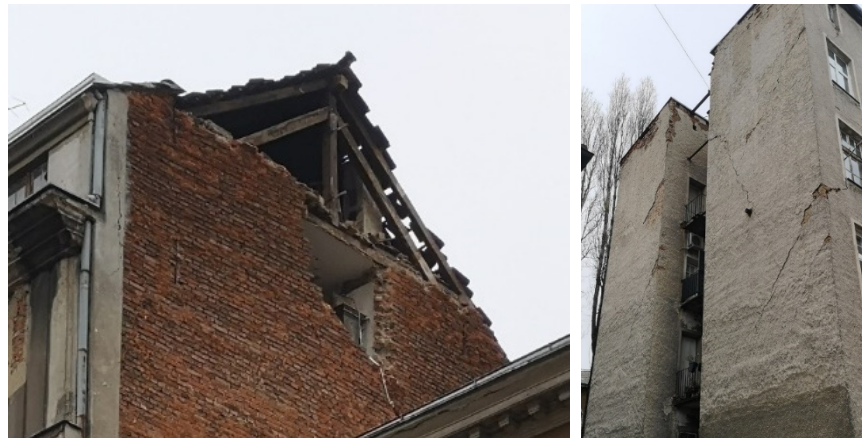
The first inspection of the building was carried out on the day of the earthquake, 22 March 2020, and the building was categorized as temporarily unusable. Severe damage to partition walls, and moderate damage to most load-bearing walls except for the courtyard wall that was severely damaged, was observed. The gables in the attic space of the building and the chimneys were also severely damaged. Slight damage was recorded to the floor

structures, the staircase, and the roof structure, with indications of very severe damage to the chimney and some of the tiles falling off. Photographs of the damage are shown in Figure 6.

**Figure 6.** Photographs from damage assessment of the building after the Zagreb earthquake.
