Damage Evaluation and Seismic Assessment of a Typical Historical Unreinforced Masonry Building in the Zagreb 2020 Earthquake: A Case Study—Part I

Keywords: earthquakes in Croatia; unreinforced masonry building; seismic assessment; nonlinear static analysis

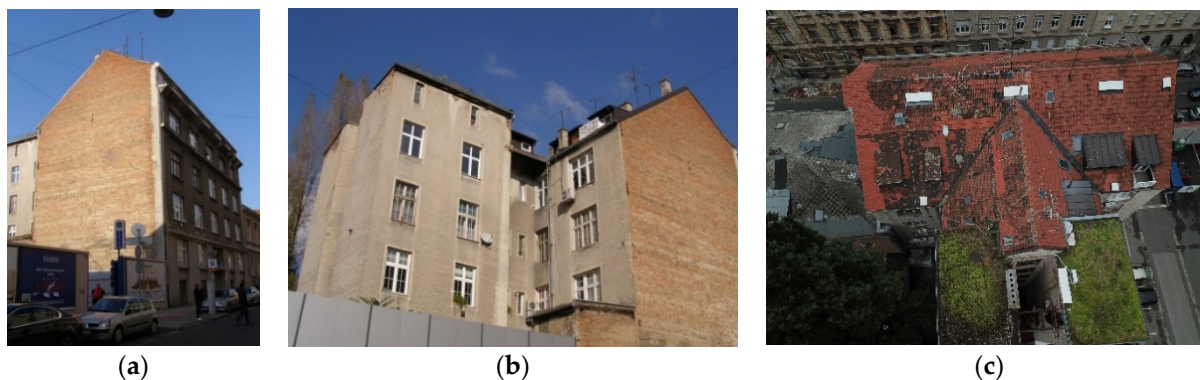
Figure 3. Photographs of the case study building: (a) south- and street-facing facade; (b) side view; (c) aerial view.

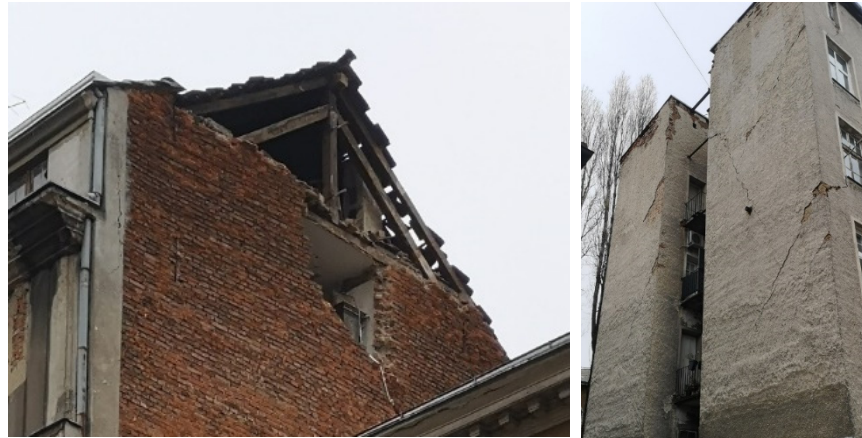
The first inspection of the building was carried out on the day of the earthquake, 22 March 2020, and the building was categorized as temporarily unusable. Severe damage to partition walls, and moderate damage to most load-bearing walls except for the courtyard wall that was severely damaged, was observed. The gables in the attic space of the building and the chimneys were also severely damaged. Slight damage was recorded to the floor

structures, the staircase, and the roof structure, with indications of very severe damage to the chimney and some of the tiles falling off. Photographs of the damage are shown in Figure 6.

Figure 6. Photographs from damage assessment of the building after the Zagreb earthquake.

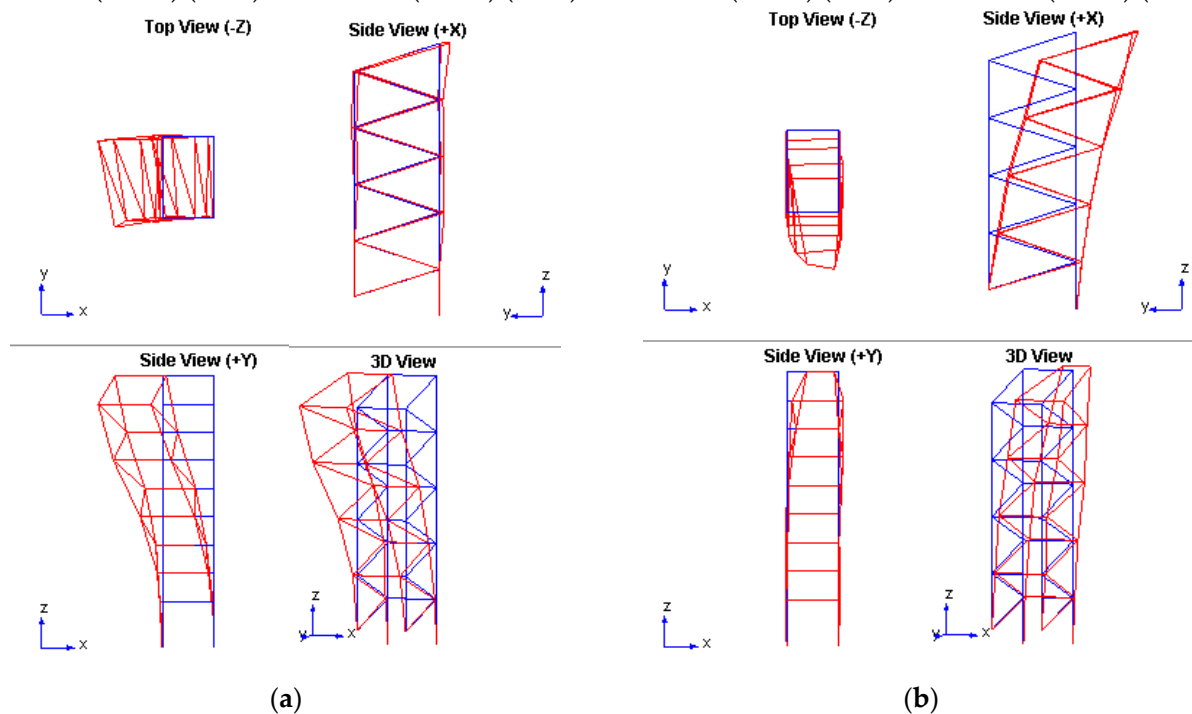
Figure 9 graphically shows the main vibration modes of the building and allows for a comparison of the measurements taken before and after the earthquake in Zagreb. It may be noted that the mode shapes do not change between the two measurement periods (before and after the earthquake). It is obvious that the periods of the fundamental modes of vibration were prolonged due to the damage caused by the earthquake. For example, the first mode of vibration in the X direction (longitudinal direction) was 0.39 s before the earthquake but 0.50 s after the earthquake. This corresponds to a reduction in global stiffness of about 40%. The second mode of vibration, which predominates in the Y direction (transverse direction), had a period of 0.32 s and 0.38 s after the earthquake. Thus, the reduction in global stiffness due to the earthquake damage is about 30%. These data clearly show that the stiffness of the load-bearing elements of the building has decreased.

2.55 Hz (0.38 s) (2014) vs. 1.98 Hz (0.50 s) (2020) 3.10 Hz (0.32 s) (2014) vs. 2.63 Hz (0.38 s) (2020)

Figure 9. Experimentally obtained (a) first (dominant) translation mode shape in y direction, and (b) second translation mode shape in X direction. The blue lines represent the undeformed shape, while the red lines represent the deformed shape.

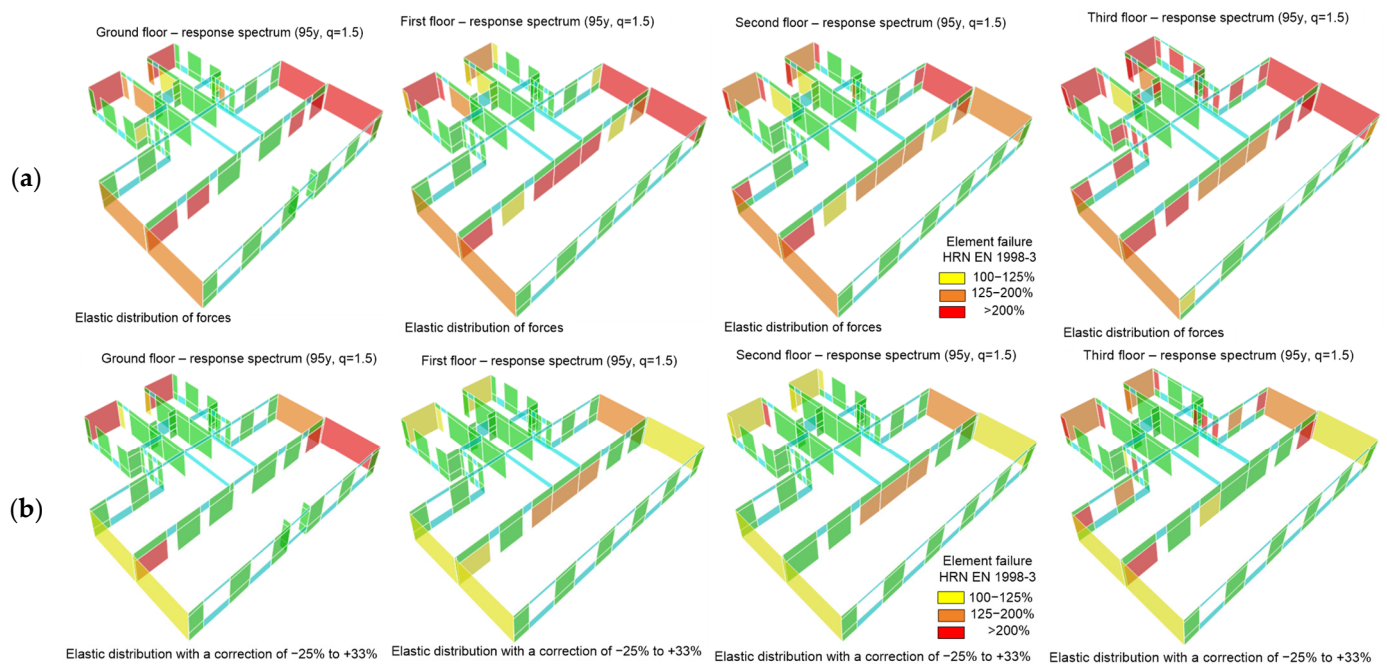
The following Figure 14 shows the results of wall seismic capacity analysis. It is evident that many elements exceed their shear force capacity by more than 200%, with some walls exceeding the load factor by more than 300%, which is well above the permissible values. In order to account for redistribution of forces due to nonlinear behavior of elements in this type of linear analysis, a redistribution of forces in load-bearing elements ranging from -25% to $+33\%$ was performed (according to the Eurocode). The condition for the application of the redistribution is that the resultant lateral force is unchanged (same intensity and position in each story). Figure 14b illustrates the outcomes of this redistribution, indicating that it has a beneficial impact on the utilization of the cross-section. It is important to highlight that a 25% reduction in internal forces in the critical element does not necessarily lead to a 25% decrease in utilization.

Figure 14. Summary of the wall shear capacity for seismic action with a 95-year return period (behavior factor 1.5) (a) without and (b) with redistribution performed.

In unreinforced masonry, high forces often lead to a significant reduction in the compressive area of the wall, which is crucial for its resistance to lateral loads. Therefore, a 25% reduction can significantly increase the compressive area and lead to even more of an increase in the element resistance. Besides the resistance of individual elements, it is important to consider the condition of the resultant force during redistribution of the 25% force from critical elements. If the structure has a high degree of static indeterminacy, this is not commonly a problem. However, if there are only a few walls in the floor plan or if there are individual walls that dominate the bearing of lateral loads (typically massive and/or long walls), satisfying the equality of the resultant force can be challenging. In this study, after conducting redistribution of forces in the model, a certain reduction in the utilization of the capacity of the elements was achieved; however, there were still elements exceeding the bearing capacity by over 200%.
