Damage Evaluation and Seismic Assessment of a Typical Historical Unreinforced Masonry Building in the Zagreb 2020 Earthquake: A Case Study—Part I

Keywords: earthquakes in Croatia; unreinforced masonry building; seismic assessment; nonlinear static analysis

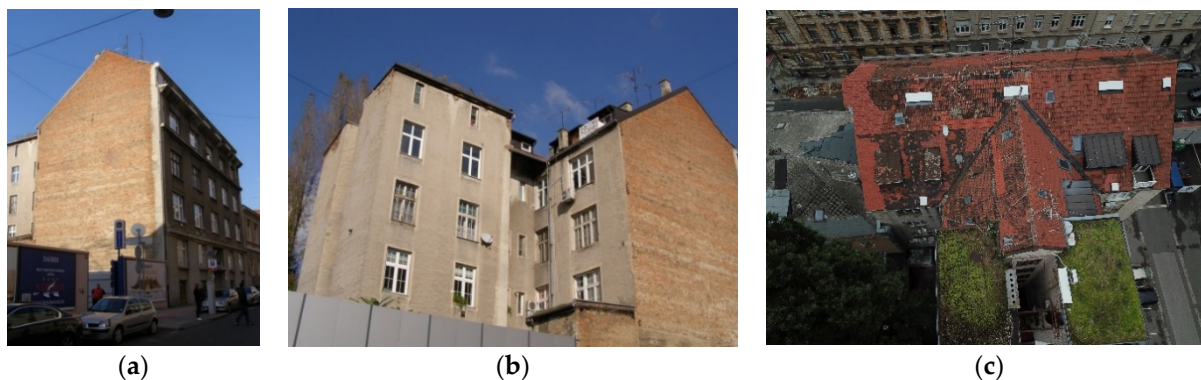
The building analyzed in this study was built in 1922 and is a typical example of a building type found in the Lower Town of Zagreb [1,5] (Figure 3). The epicentral distance to the analyzed building is approximately 8 km.

Figure 3. Photographs of the case study building: (a) south- and street-facing facade; (b) side view; (c) aerial view.
