# Damage Evaluation and Seismic Assessment of a Typical Historical Unreinforced Masonry Building in the Zagreb 2020 Earthquake: A Case Study—Part I

Source / Izvornik: **Buildings, 2024, 14**

**Abstract:** The city of Zagreb, the national capital and economic hub of Croatia, is situated in a seismically active region and hosts a significant array of historical buildings, from the medieval to Austro-Hungarian periods. These buildings possess varying but generally high degrees of vulnerability to seismic loading. This was highlighted in the Zagreb earthquake of 22 March 2020, emphasizing the need for seismic retrofitting in order to preserve this architectural heritage. In this paper, the seismic capacity of one such unreinforced masonry building is considered through a number of analysis methods, including response spectrum, pushover, and out-of-plane wall failure analyses. Given the advantages and disadvantages of the individual methods, their applicability and value in a seismic analysis is considered. Ambient vibration measurements before and after the Zagreb 2020 earthquake, used for model calibration, are also presented. Conclusions are drawn from each individual analysis and

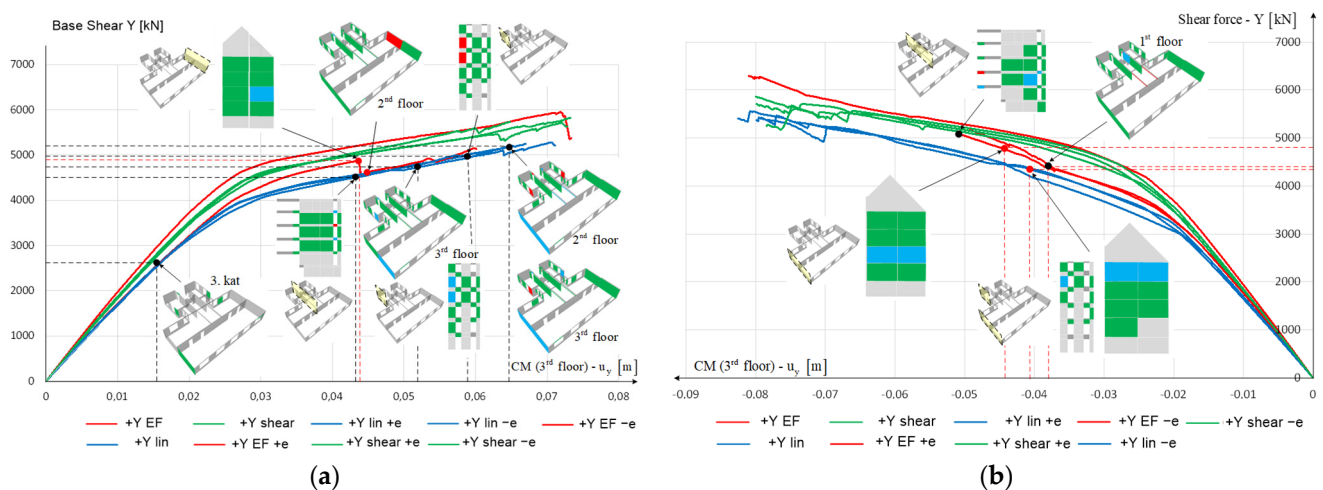
Capacity curves for the positive Y direction of lateral force are shown in Figure 18a. It is evident from the figure that some structural elements experienced an LD state when the base shear reached 2600 kN (B.S. = 8.1%) and the displacement of the 3rd floor CM was 1.6 cm. Primarily, these elements were located on the 3rd floor.

**Figure 18.** Relevant capacity curves of the building: (a) in the +Y direction. (b) in the -Y direction.

Just like the previous load case, applying the load in the Y direction also led to a consistent occurrence of exceeding the limit state for spandrels in terms of the SD. The spandrels that were critical and had limited rotation capacity were located at the edge of the central transverse wall along the staircase towards the west side of the building. The structural piers first exhibited failure when subjected to a lateral force of 4500 kN

(B.S. = 14%) and a displacement of 4.3 cm at the 3rd floor CM. The piers located on the north side of the building's north gable wall were the primary components that initially reached the SD limit state. This included the piers on the 1st floor, followed by the capacity of the piers on the 2nd floor being exceeded. Depending on the eccentricity of the load, the outermost south walls could also be regarded as critical components due to the building's symmetry in this direction. An interesting observation made of the capacity curve was a sudden significant drop (red curve) caused by the failure of the piers of the north gable wall. Despite the failure of several piers, the total lateral force continued to increase as the load increased. The walls of the courtyard façade on the 2nd and 3rd floors were the next elements where the SD limit state was exceeded in the transverse direction. As for the X direction, the building experienced critical pier failures primarily on its upper levels. Although the SD limit state was reached in several elements, the structure still maintained load-bearing capacity and ductility, preventing the building from collapsing. The ultimate displacement of the 3rd floor CM during global building collapse was estimated to be around 6.0 cm. The basement and ground floor walls were not considered critical for action in the positive Y direction.

The capacity curves for the lateral load in the negative Y direction (Figure 18b) indicate that the critical components were the spandrels, which reached the SD limit state first. In addition to the south gable wall, the staircase wall in the courtyard on the first floor of the building was also identified as critical for this load direction. In addition, it is important to note that the load-bearing capacity of reinforced concrete beams in the axes of the staircase was exceeded.

The failure mechanism of the vertical load-bearing system started when the piers in the south gable wall on the 3rd floor or in the western part were affected by the damaged piers in the staircase wall on the 1st floor of the building. These piers reached an SD limit state when subjected to a lateral force of about 4300 kN and a displacement of the 3rd floor CM of 3.9 cm.

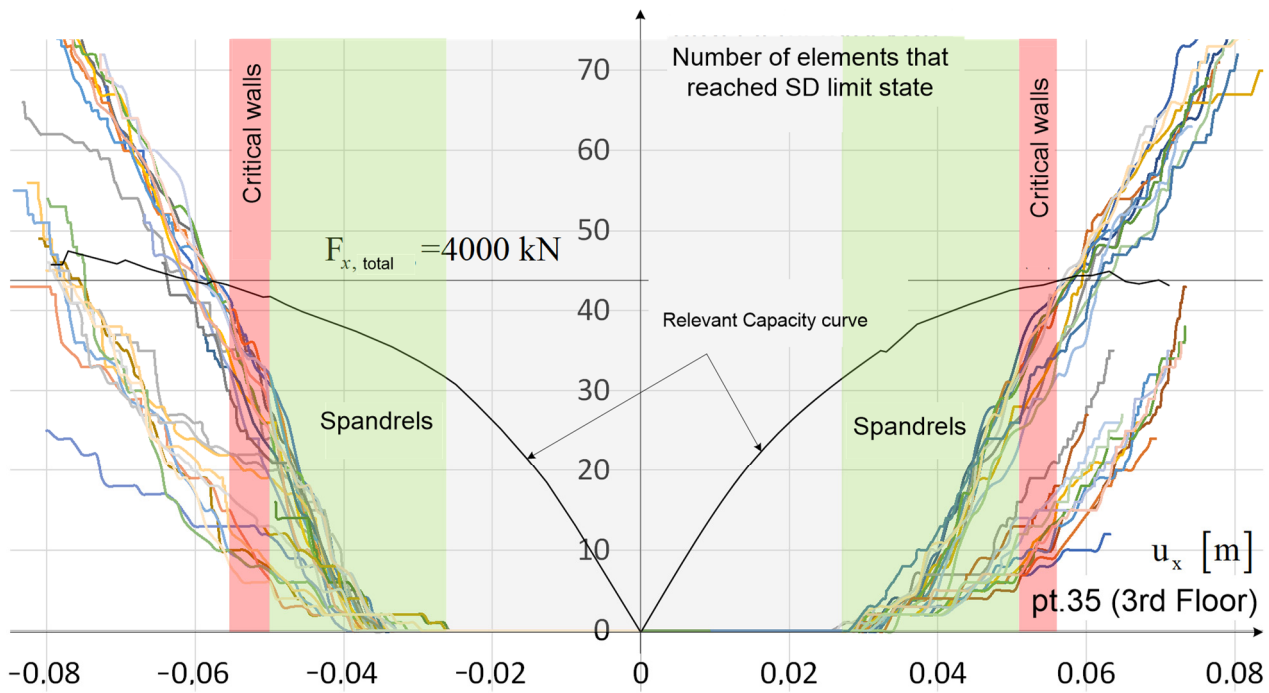
Figure 19 presents a diagram showcasing the cumulative count of elements that reached the significant damage limit state. The diagram overlaps with the most important bearing capacity curve for the X direction. An area where the spandrels begin to enter a state of SD (highlighted in green) can be observed. It can be seen that in this area, a large number of spandrels, depending on the load case, enter a state of SD, and for critical cases already analyzed, the number is 38. After that, at a displacement of CM of about 5.1 cm, the critical pier enters a state of SD (red area), and soon after that, the critical pier also fails (near the red area).

Figure 19. Number of elements that have reached the limit state SD as a function of the control point displacement.

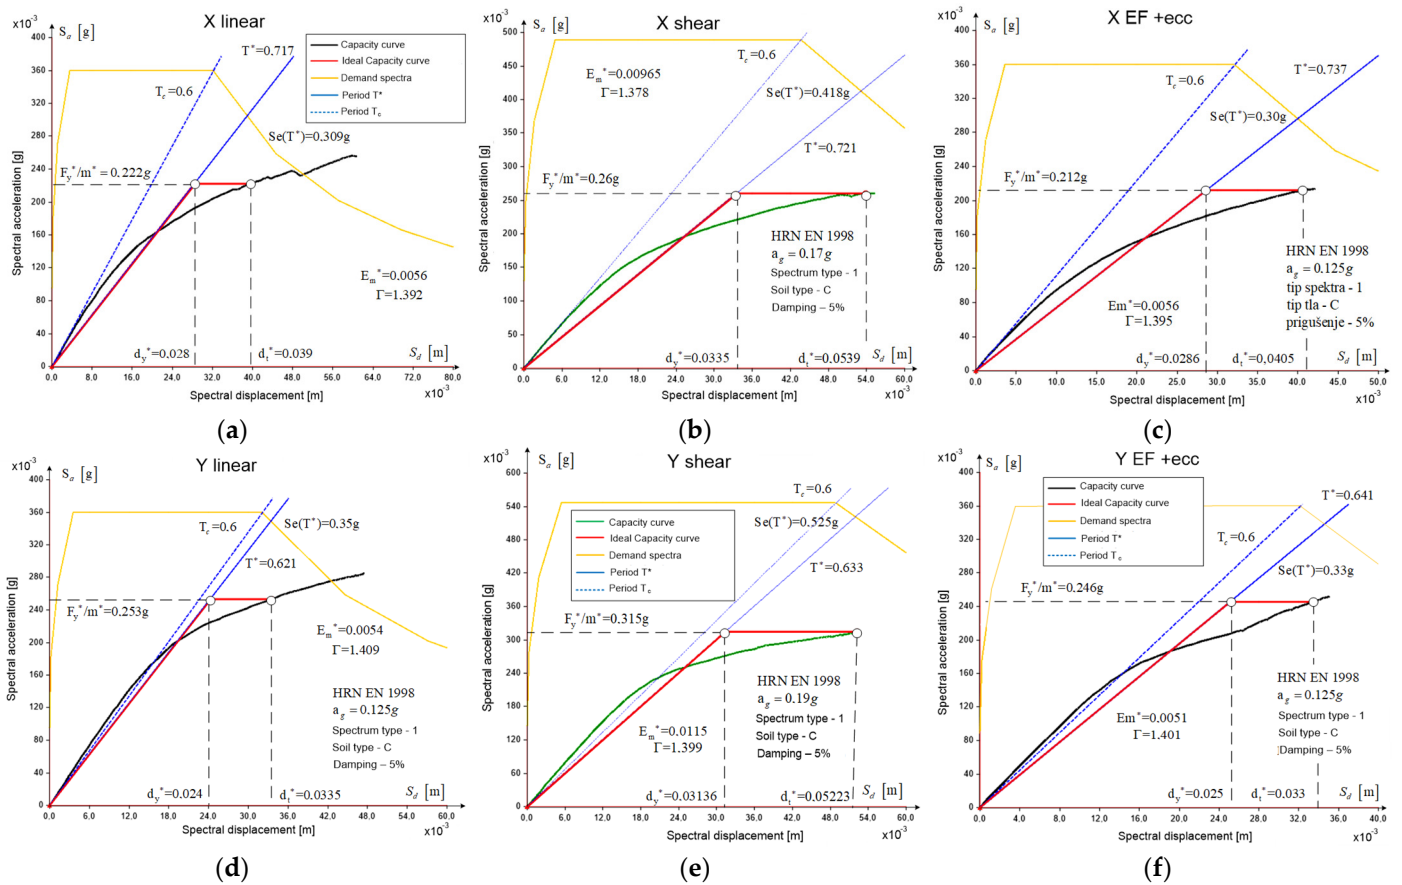
Figure 20a,d show idealized bearing capacity curves of an equivalent SDOF system for a PGA of 0.125 g (r.p. 95 years—level 2) and for linear load distribution without eccentricity. The system's deformation capacity in both directions is higher than required. The maximum PGA value that would satisfy the demand in this case of load distribution is approximately 0.17 g for the X direction and 0.16 g for the Y direction. It should be noted that this load case is not paramount but is presented only to illustrate the main parameters and coefficients.

Figure 20. Relevant capacity curves of the building: linear load distribution directions X (a) and Y (d). shear load distribution directions X (b) and Y (e). lateral load method distribution directions X (c) and Y (f).

Similarly, Figure 20b,e show an idealized load capacity curve of an equivalent SDOF system for a PGA with 0.17 g in the X direction and 0.19 g in the Y direction for shear load distribution without eccentricity, as well as the load distribution during deformation of the shear building (parabola) also without eccentricity. It can be seen that for both distributions, the building has a similar deformation capacity that satisfies the ground acceleration requirement on the bedrock, of 0.17 g and 0.19 g, respectively, which is approximately equivalent to the earthquake return period of 225 years.

Figure 20c,f show the idealized capacity curve of an equivalent system for a ground acceleration on the base rock of 0.125 g for the X and Y directions and for a distribution of load over the height of the building using the lateral force method with a 5% eccentricity of the building width. The system deformation capacity can be concluded to be approximately equal to the required capacity. The maximum ground acceleration on the bedrock that fulfils the displacement requirement is close to 0.125 g, and this load case is critical. The system deformation capacity can be concluded to be close to the requirements, and we can surmise that there are no load-bearing reserves for horizontal actions.

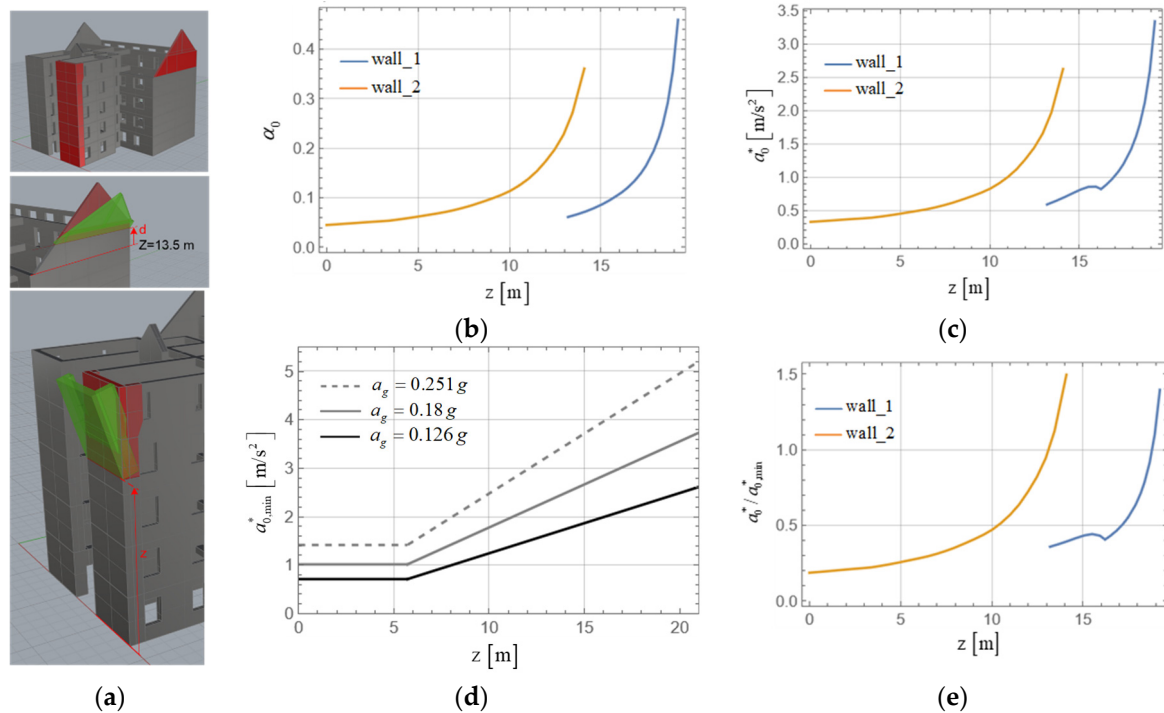
For these two walls shown in Figure 21a, the position of the line hinge was considered to be a variable parameter. The results for the activation coefficient and corresponding spectral acceleration are given in Figure 21b,c. As the position of the line hinge increased over the height of the building, the volume of each block decreased and, as a consequence, the activation factor increased, manifesting the ratio of the thickness and height, i.e., elements with higher slenderness had a lower activation factor.

**Figure 21.** (a) Solid model of the case study building and selected overturning local mechanisms in Rhinoceros; (b) activation factor; (c) spectral acceleration that activates mechanism; (d) minimum demanded value for the spectral acceleration over the building height; and (e) safety factor value for the 95-year return period of seismic action.

In order to compare this to seismic action, the demand  $a_{0,min}^* = \max\left(a_g \frac{S}{q}; S_e(T_1) \Gamma_1 \frac{z}{H} q\right)$  was used, where the participation factor of the fundamental mode approximated by the number of stories is  $\Gamma_1$ ,  $z$  is the height of the formation of the line hinge,  $H$  is building height, and  $q$  is a factor with the value 2. The corresponding minimum values are plotted for different return periods in Figure 21d. When comparing demand values with those obtained in the analysis, it was evident that for the return periods of 475 and 225 years, it does not satisfy requirements for all considered mechanisms except for wall\_3. However, it should be mentioned that the formation of the line hinge of wall 2 below  $z = 10$  m is unlikely because this mechanism assumes the formation of cracks on all spandrels of the orthogonal wall that will contribute to the separation of the considered wall. Furthermore, for the 95-year return period, the activation demand was satisfied in the case of a line hinge forming above the height of 13 m for the west courtyard wall (wall\_2), and for gable (wall\_1) above approximately  $z = 18.5$  m. Nevertheless, it is worth mentioning that this analysis considered only the activation of the mechanism and not the eventual overturning of walls. Furthermore, this criterion is in most cases conservative, which is common of linear methods. Although the position of the line hinge of the presumed mechanisms shifted toward higher floors and the value of the activation acceleration increased, which was favorable, the walls of higher floors were still more prone to out-of-plane failure. Elements of the higher floors tended to be subjected to higher values of floor acceleration and generally had fewer connections, which constrained the mechanism to some extent, or like gable wall\_1, they had no constraint at all. In the case of the two-story bending mechanism (wall\_4), our investigation of the 95-year return period of seismic action returned an acceptable degree of

safety. However, the formation of this kind of mechanism is highly dependent on adequate constraint at the top of the mechanism.

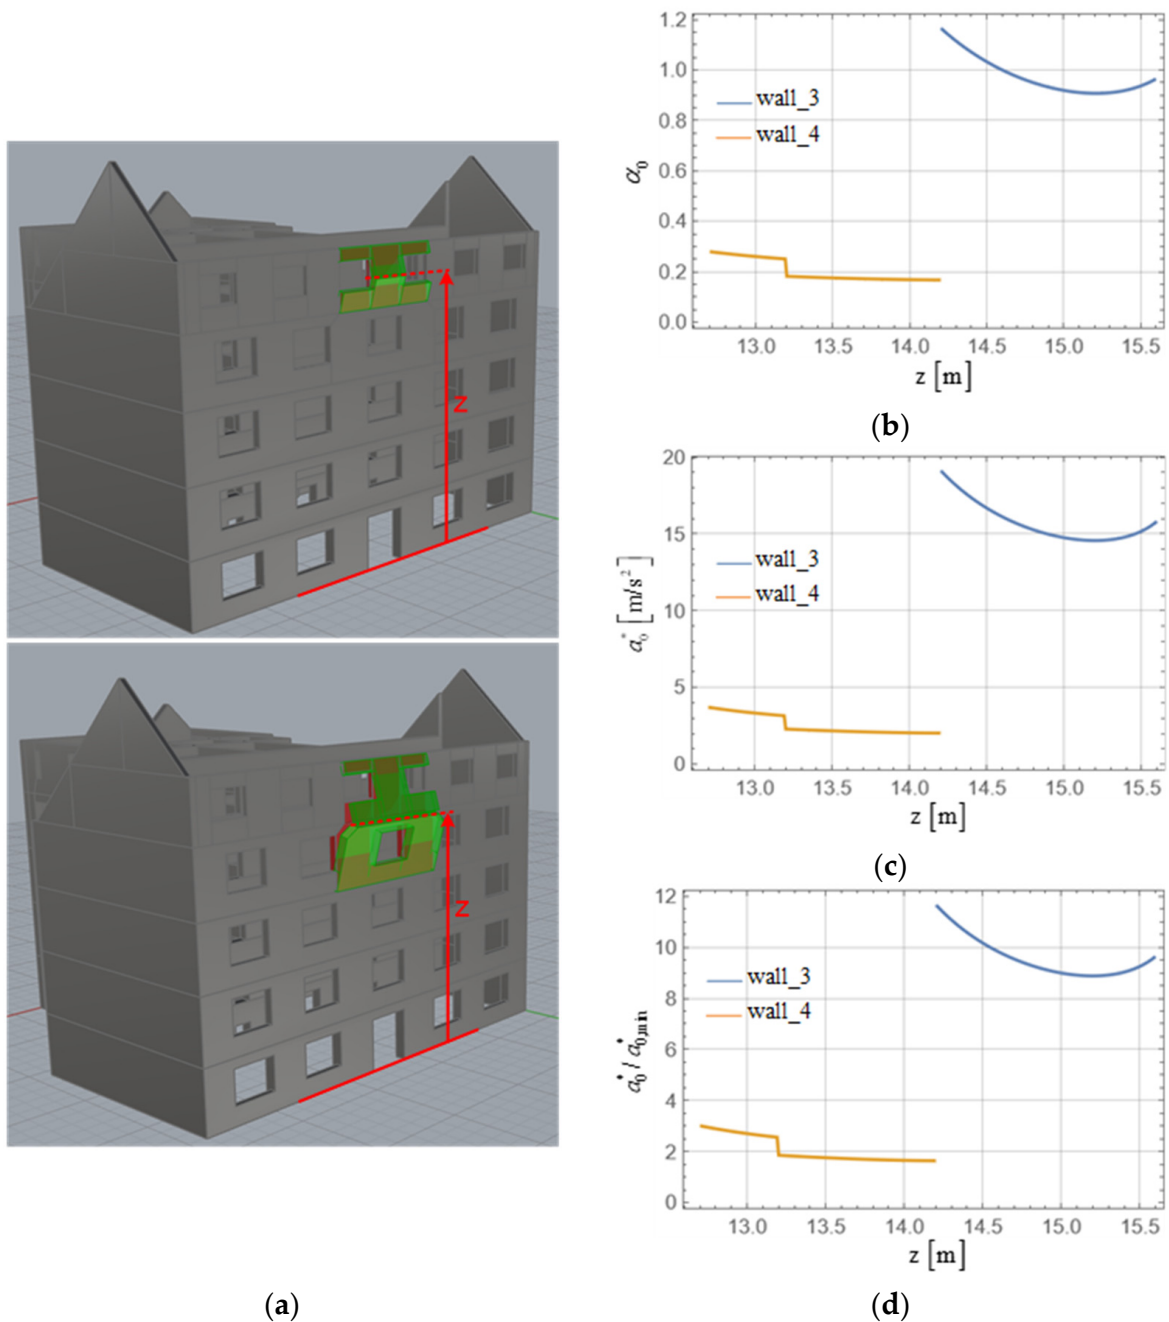
In addition, for the type of mechanism that considers the formation of an internal line hinge and the formation of a kinematic chain, two cases of façade walls were considered. It is worth noting that for these cases, a relatively good connection between floor structures and walls was assumed. The vertical position of the inner line hinge is assumed to be a variable parameter. For wall\_3, it was assumed to form over the height of the pier and, for wall\_4, it was assumed to form between the openings of the lower and upper floors. The results in Figure 22 show that the one-story mechanism (wall\_3) had a high activation requirement regardless of the position of the internal line hinge formation. However, if the geometry of the local mechanism included two stories (wall\_4), the activation coefficient

decreased considerably. Moreover, in this case, the sudden drop in the activation coefficient and spectral acceleration observed for the formation of the internal hinges at 13.2 m was a consequence of the change in wall thickness from 45 cm (lower story) to 30 cm (upper story), which was taken into account in the numerical calculation.

**Figure 22.** (a) Solid model of the one-story (wall\_3) and two-story (wall\_4) bending local mechanisms in Rhinoceros; (b) activation factor; (c) spectral acceleration that activates mechanism; and (d) safety factor value for the 95-year return period of seismic action.
