Damage Evaluation and Seismic Assessment of a Typical Historical Unreinforced Masonry Building in the Zagreb 2020 Earthquake: A Case Study—Part I

Keywords: earthquakes in Croatia; unreinforced masonry building; seismic assessment; nonlinear static analysis

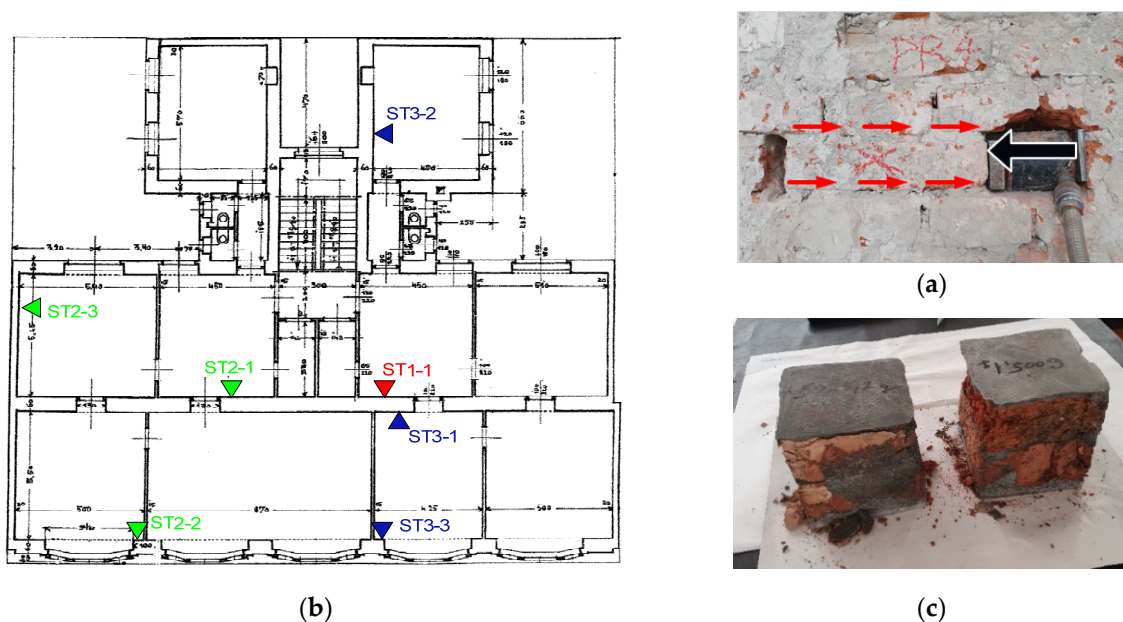
where f_v is the shear strength of the masonry, μ is the coefficient of friction, σ_0 is the normal compressive strength, F_h is the experimentally determined shear force at the time of shear failure, and A_u and A_l are the upper and lower areas of the brick. With the selected in situ method, it is possible to obtain f_{v0} . First, f_v must be determined experimentally, and then the value of the friction coefficient can be assumed to be 0.4 (HRN EN 1998-3) and the vertical compressive stress can be obtained from the numerical model. The advantage of the chosen method is that it can be carried out in a short time (45 min/location). However, the disadvantage of the method lies in the assumptions already mentioned. In this study, the protective layer of the plaster was removed at a total of eleven locations, a shear test was performed at seven locations, and the remaining four locations were only used for visual identification of the masonry. All shear tests were carried out approximately 100 centimeters above the floor, on the locations shown in Figure 7. The results of the shear test and compressive strength we performed are summarized in Table 2.

Figure 7. (a) Characteristic floor plan and locations of the shear test, (b) shear test of mortar without control of vertical stress, (c) samples for determination of compressive strengths of solid bricks.

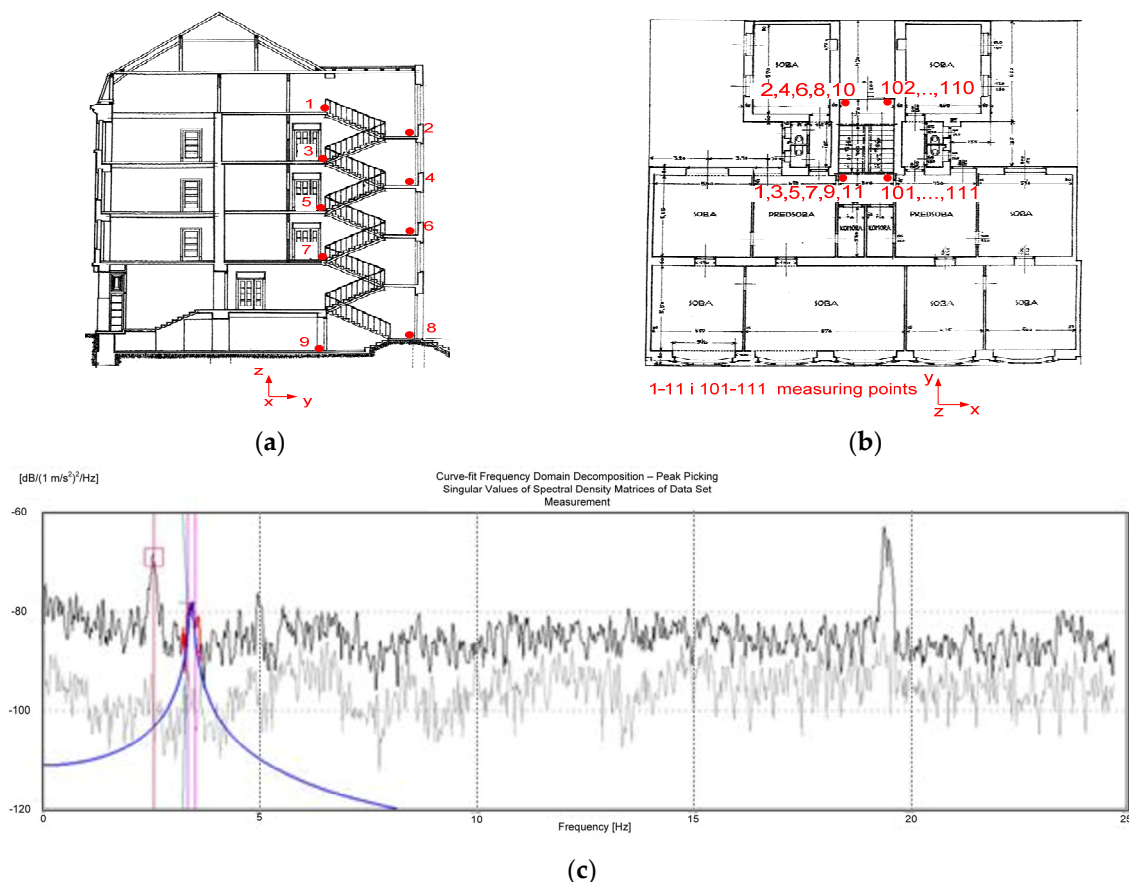
The measurement of the ambient vibrations of the studied building was carried out in October 2014 and September 2020 (number of degrees of freedom measured: 44). The measurement points were located in the core of the staircase and are shown in Figure 8. The measurements were performed in two horizontal directions (X and Y directions). A classical frequency domain decomposition (FDD) was used for the estimation of natural frequencies (Table 3) and mode shapes (Figure 8), while the enhanced frequency domain composition (EFDD) method was used for the estimation of damping.

Figure 8. Measurement point locations (a) in cross-section and (b) in floor plan. (c) Characteristic record of frequency domain decomposition (FDD) for the determination of natural frequencies.

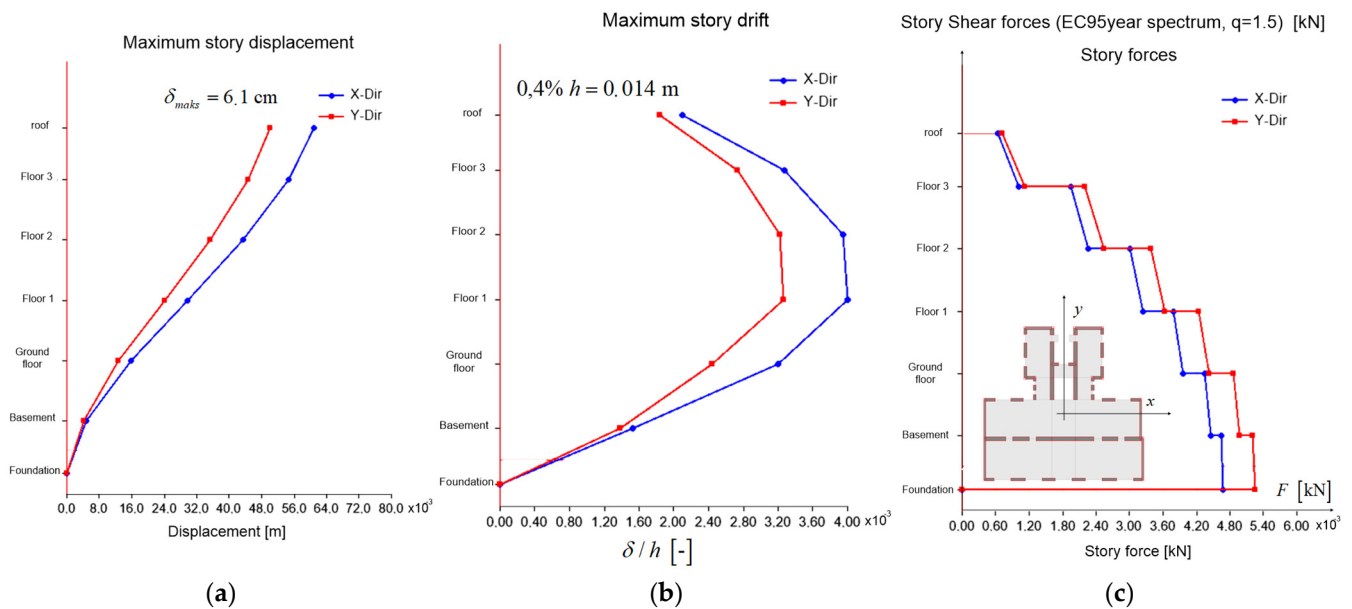
Figure 13. Response spectrum method results: (a) maximum story displacements. (b) maximum story inter-story drifts. (c) seismic lateral forces in the X and Y directions for a 95-year return period.

It can be observed that the maximum displacements are close to reaching the SD limit state and are up to 6 cm for the X direction and 5 cm for the Y direction in the attic. The maximum value of story drift for the X direction is approximately 0.004 ($\Delta/h = 0.4\%$), which is also the bounding value for the SD limit state for elements for which the shear failure mechanism is critical. This is not realistic since the model is linear–elastic, so displacement can be expected to be larger.

The distribution of story shear forces obtained using the design spectrum for a return period of 95 years is shown in Figure 13c. In the case of a 95-year return period, the value of the base shear (BS) coefficient is 15% for direction X and 16% for direction Y. The average shear stress in each story for a 95-year return period is between 0.14 and 0.16 MPa for the X and Y directions, with higher values corresponding to higher floors due to lesser thicknesses of walls. It is important to note that this method of calculating shear stress provides only a rough estimate and does not accurately represent the actual distribution. Since it is anticipated that the building will not meet the conditions of a 475-year return period earthquake, the analysis focuses on the effects of the 95-year earthquake ($a_g = 0.125$ g).

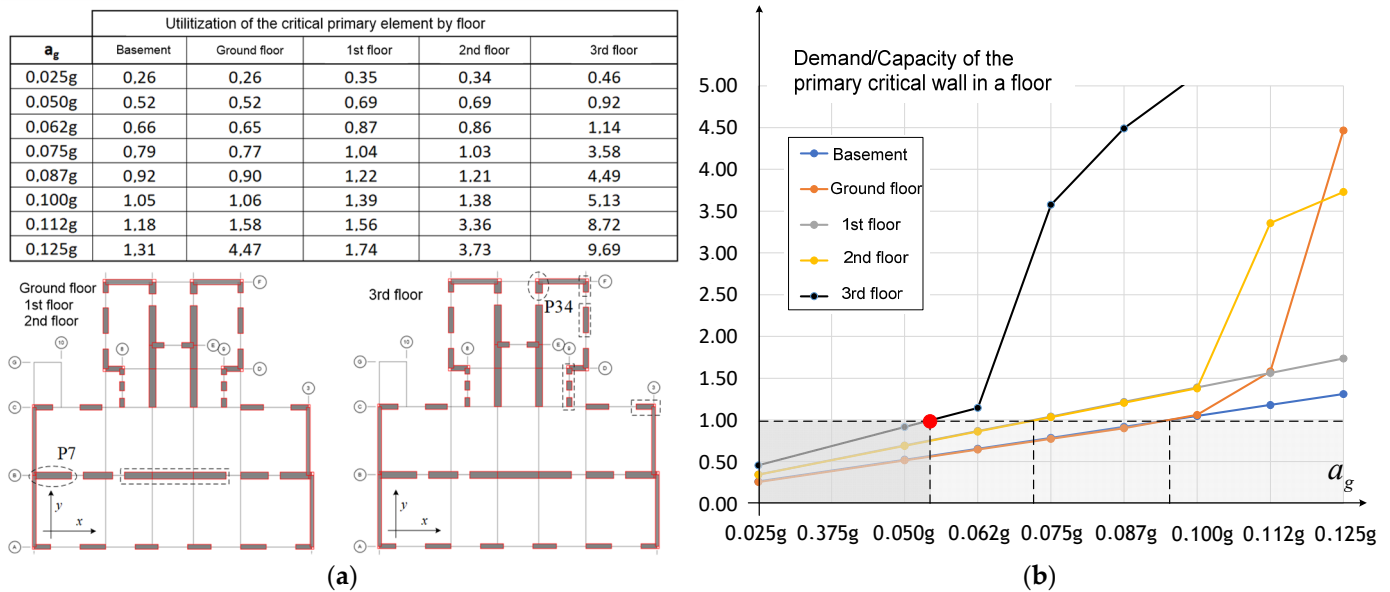
Figure 15. Parametric analysis results for a_g . (a) critical element utilization by story. (b) demand/capacity of the primary critical wall in each story.

The SD limit state of the building was determined based on the critical elements on the 3rd floor, and was found to be only 43% of the demand for $a_g = 0.125$ g. The SD limit state of critical elements on the 1st and 2nd floors was then found to be 58%, while in the basement and on the ground floor, we found it to be 76% of the 95-year return period ground acceleration.

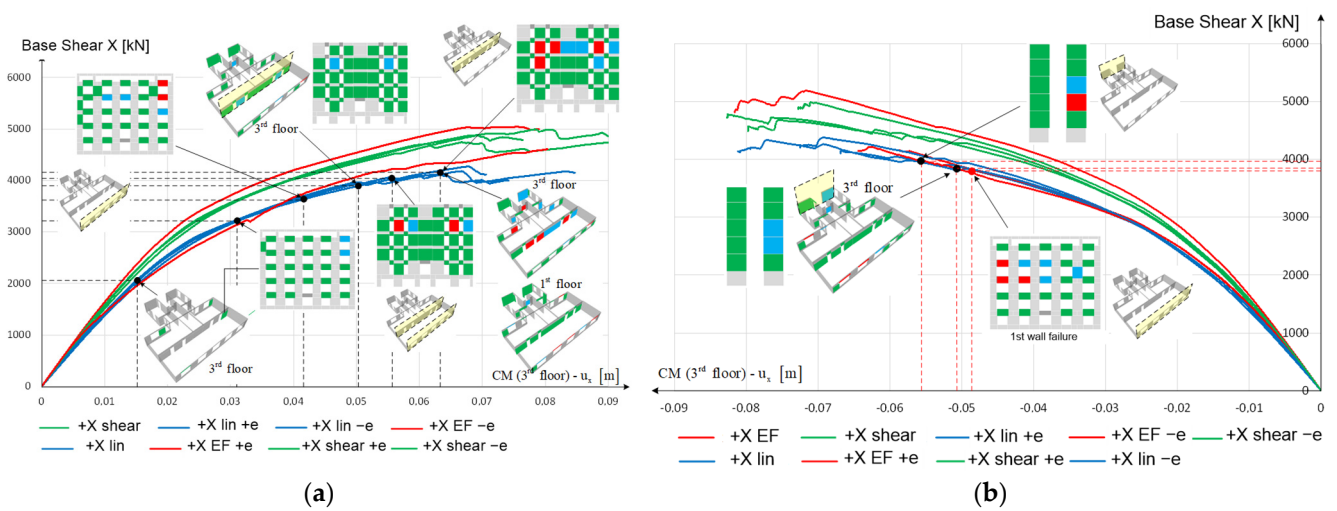
Figure 17. Relevant capacity curves of the building: (a) in the +X direction. (b) in the -X direction.

At a base shear value of approximately 2000 kN (base shear factor—BS = 6.2%) and a displacement of the CM on the 3rd floor of 1.5 cm, several structural elements reached a state of limited damage, resulting in a decrease in stiffness, as observed on the pushover curve. As the base shear increased, cracks opened, the stiffness of the building decreased, and damage occurred of several elements. The damage began on the 3rd floor of the building, where the load-bearing elements reached their yielding point. Nonetheless, these masonry structural elements have the ability to deform beyond their yielding point while retaining their load-bearing capacity. Therefore, an adequate approximation of the

The capacity curves for the negative X direction of the lateral load are depicted in Figure 17b. Similar to the previous case, the spandrels were the first to reach the SD limit state and so could be considered critical. In this scenario, the failure mechanism of the load-bearing system was initiated with the failure of the western courtyard wall on the 1st and 2nd floors. These walls reached the SD limit state at a lateral force of 3900 kN and a CM displacement of the 3rd floor of 5.1 cm, and their failure occurred when the displacement reached 5.6 cm. These piers were relatively rigid and located far from the CM, exposing them to significant shear forces caused by torsional effects resulting from the asymmetry and eccentricity of the load.
