Damage Evaluation and Seismic Assessment of a Typical Historical Unreinforced Masonry Building in the Zagreb 2020 Earthquake: A Case Study—Part I

Keywords: earthquakes in Croatia; unreinforced masonry building; seismic assessment; nonlinear static analysis

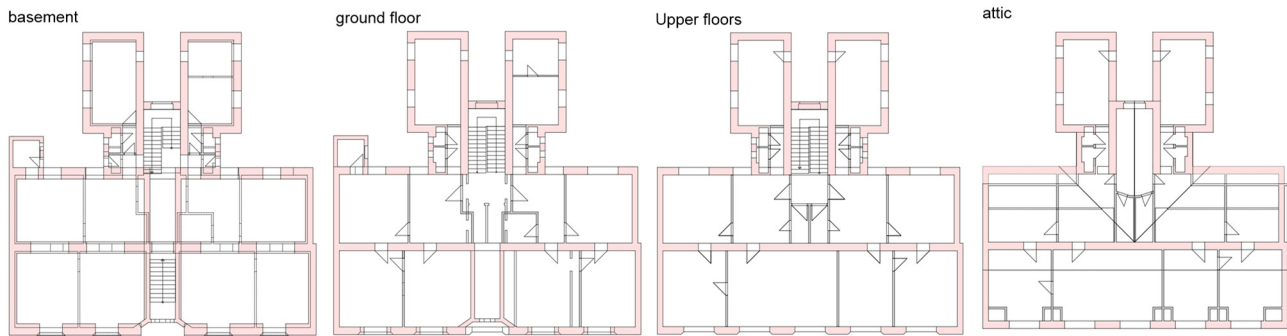
Figure 4. Floor plans of the as-built state of the building.

The dimensions of the floor plan are 24.4×12 m on the street side and 10.6×12 m on the courtyard side, resulting in a gross floor plan area of approximately 407 m^2 and total gross area of the building of around 2440 m^2 . The building consists of a basement, ground floor, three stories, and an attic (Figure 4). The basement has a height of 3 m, while the ground and first floors are 3.5 m high. The total height of the building is 22.70 m. The annexes on the courtyard side of the existing building are connected to its main part, which faces the street. The floor plan of the building is relatively irregular, with heterogeneous floor structures.

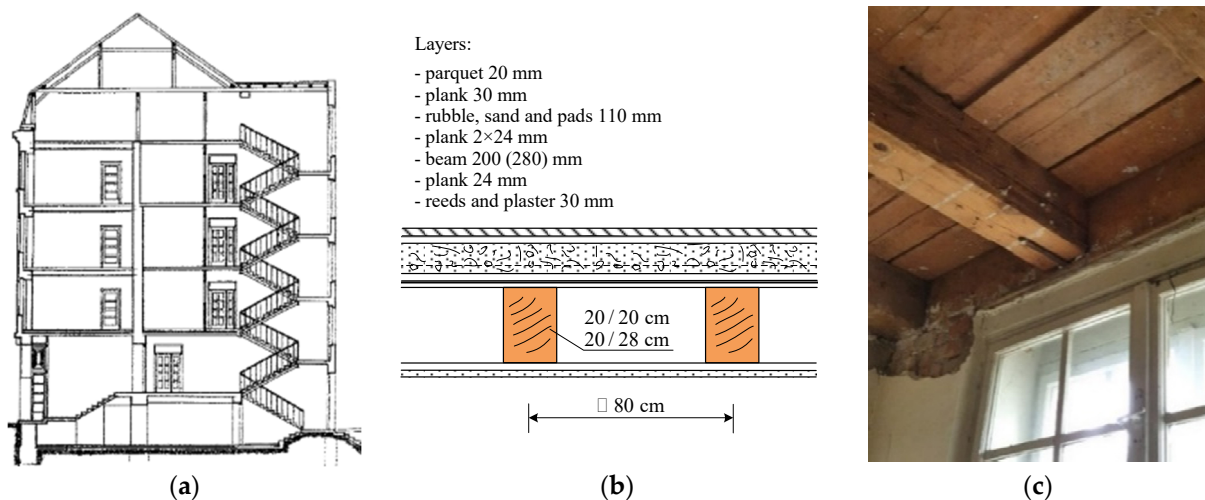
The floor structure (Figure 5) located above the basement on the street side of the building is a solid RC slab with a system of RC beams. As for the upper floors, they feature timber joists that are arranged in a transverse manner, with rubble filling used in the floor structure. During renovations, RC slabs measuring 8 cm in thickness were added above the ground floor and the third floor on the southern side of the building. The floor structure consists of timber joists with a layer of concrete with unknown reinforcement and properties on top. In the middle part of the building next to the staircase landing, there is an RC slab supported by RC beams on the edge.

Figure 5. Cross-section and timber floor structure. (a) cross-section of the building; (b) layers of the timber floor structure; (c) photograph of the timber floor structure.

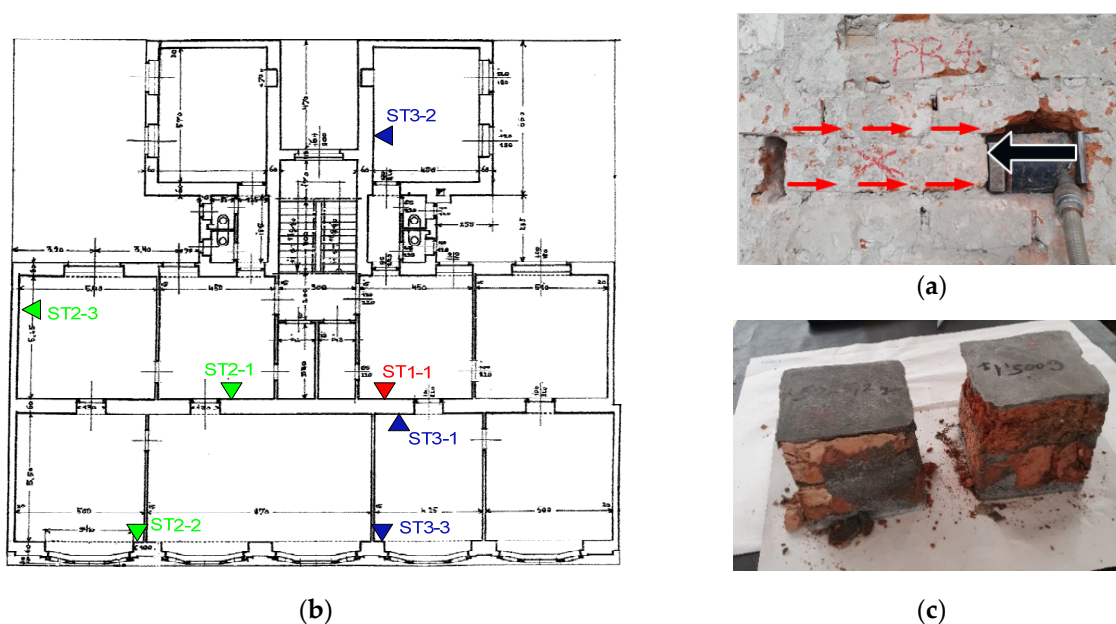
Figure 7. (a) Characteristic floor plan and locations of the shear test, (b) shear test of mortar without control of vertical stress, (c) samples for determination of compressive strengths of solid bricks.

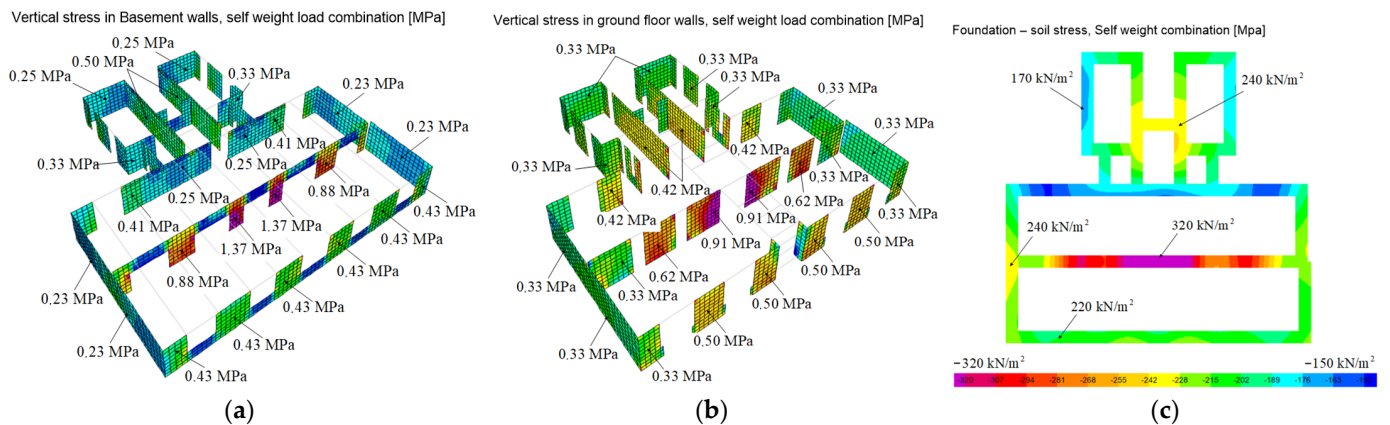
The subfigures in Figure 11 show the load-bearing elements' normal stresses due to the permanent vertical loads in the basement and on the ground floor. The average stresses of the walls are mainly between 0.3 and 0.6 MPa.

Figure 11. Normal stress distribution and soil stresses (for permanent vertical load). (a) stress distribution in the basement walls. (b) stress distribution in the ground floor walls. (c) soil stresses.

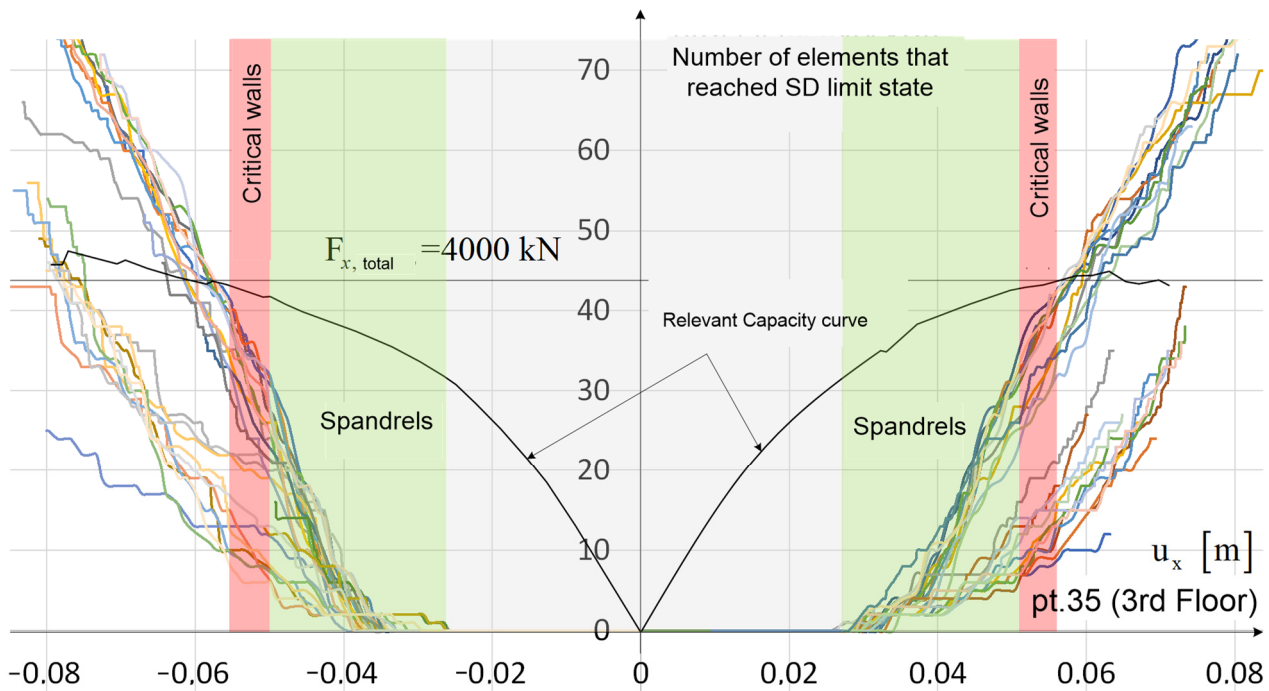
Figure 19 presents a diagram showcasing the cumulative count of elements that reached the significant damage limit state. The diagram overlaps with the most important bearing capacity curve for the X direction. An area where the spandrels begin to enter a state of SD (highlighted in green) can be observed. It can be seen that in this area, a large number of spandrels, depending on the load case, enter a state of SD, and for critical cases already analyzed, the number is 38. After that, at a displacement of CM of about 5.1 cm, the critical pier enters a state of SD (red area), and soon after that, the critical pier also fails (near the red area).

Figure 19. Number of elements that have reached the limit state SD as a function of the control point displacement.

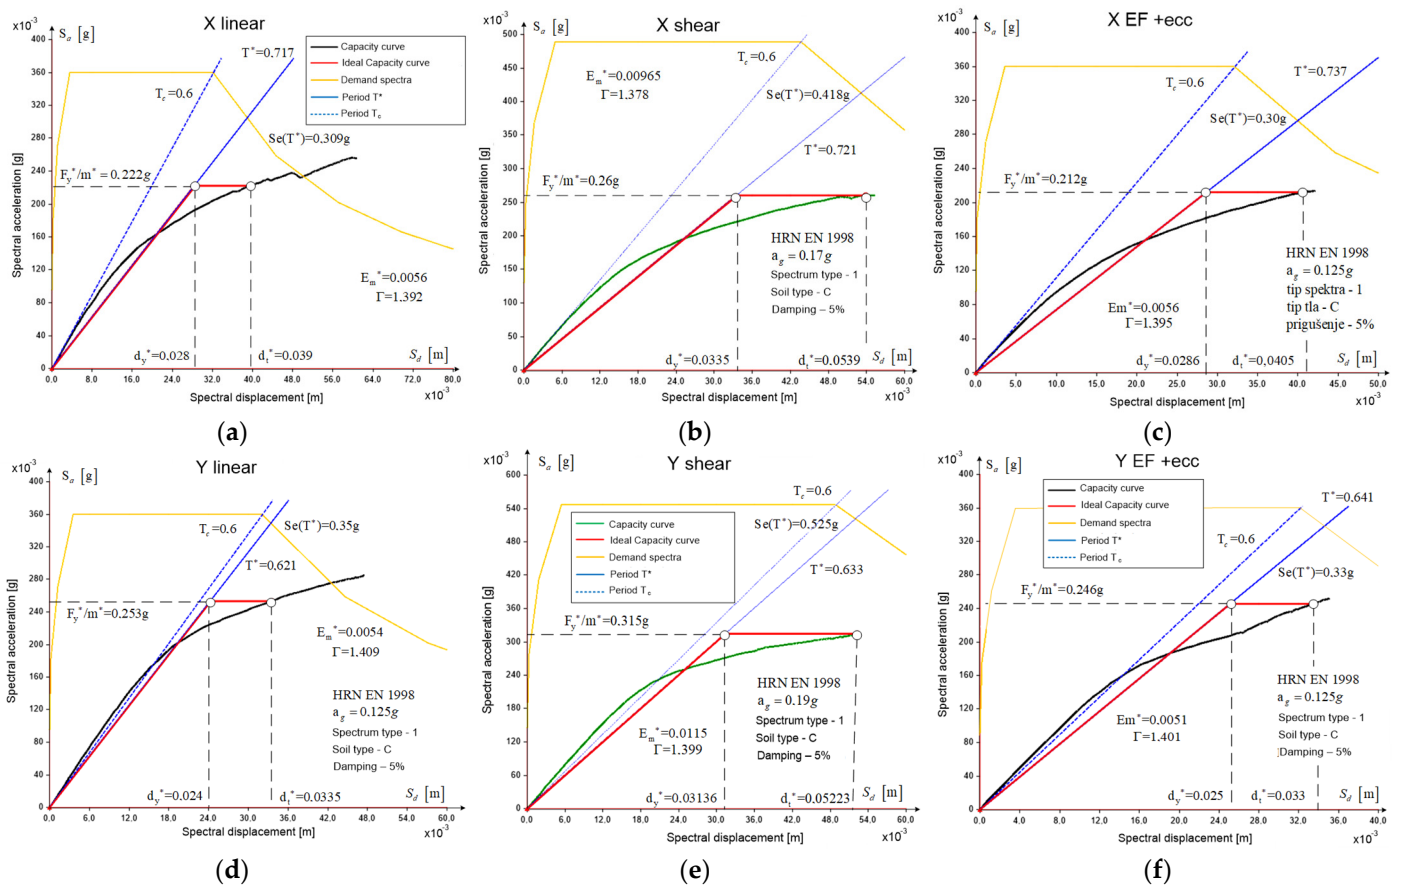
Figure 20a,d show idealized bearing capacity curves of an equivalent SDOF system for a PGA of 0.125 g (r.p. 95 years—level 2) and for linear load distribution without eccentricity. The system's deformation capacity in both directions is higher than required. The maximum PGA value that would satisfy the demand in this case of load distribution is approximately 0.17 g for the X direction and 0.16 g for the Y direction. It should be noted that this load case is not paramount but is presented only to illustrate the main parameters and coefficients.

Figure 20. Relevant capacity curves of the building: linear load distribution directions X (a) and Y (d). shear load distribution directions X (b) and Y (e). lateral load method distribution directions X (c) and Y (f).

Similarly, Figure 20b,e show an idealized load capacity curve of an equivalent SDOF system for a PGA with 0.17 g in the X direction and 0.19 g in the Y direction for shear load distribution without eccentricity, as well as the load distribution during deformation of the shear building (parabola) also without eccentricity. It can be seen that for both distributions, the building has a similar deformation capacity that satisfies the ground acceleration requirement on the bedrock, of 0.17 g and 0.19 g, respectively, which is approximately equivalent to the earthquake return period of 225 years.

Figure 20c,f show the idealized capacity curve of an equivalent system for a ground acceleration on the base rock of 0.125 g for the X and Y directions and for a distribution of load over the height of the building using the lateral force method with a 5% eccentricity of the building width. The system deformation capacity can be concluded to be approximately equal to the required capacity. The maximum ground acceleration on the bedrock that fulfils the displacement requirement is close to 0.125 g, and this load case is critical. The system deformation capacity can be concluded to be close to the requirements, and we can surmise that there are no load-bearing reserves for horizontal actions.
